DELIVRE A <i>ISSUED TO</i>	T. BICHLER MUNK GmbH RUDOLF-DIESEL-STRASSE 23 D-89312 GÜNZBURG - GERMANY
OBJET <i>SUBJECT</i>	CEILING HOOK
FABRICANT <i>MANUFACTURER</i>	MUNK GmbH
REFERENCE(S) TESTEE(S) <i>REFERENCE UNDER TEST</i>	110011
REFERENTIEL(S) APPLIQUE(S) <i>STANDARD</i>	EN 60243-1 (2013)
DATE DES ESSAIS <i>TEST DATE</i>	From April 1, 2026, to April 2, 2026
NOMBRE TOTAL DE PAGE <i>TOTAL NUMBER OF PAGES</i>	11 pages
REVISION / MODIFICATION <i>REVISION / MODIFICATION</i>	00: Creation

I ITEM IDENTIFICATION

III.2 Electrical test on Ceiling hook

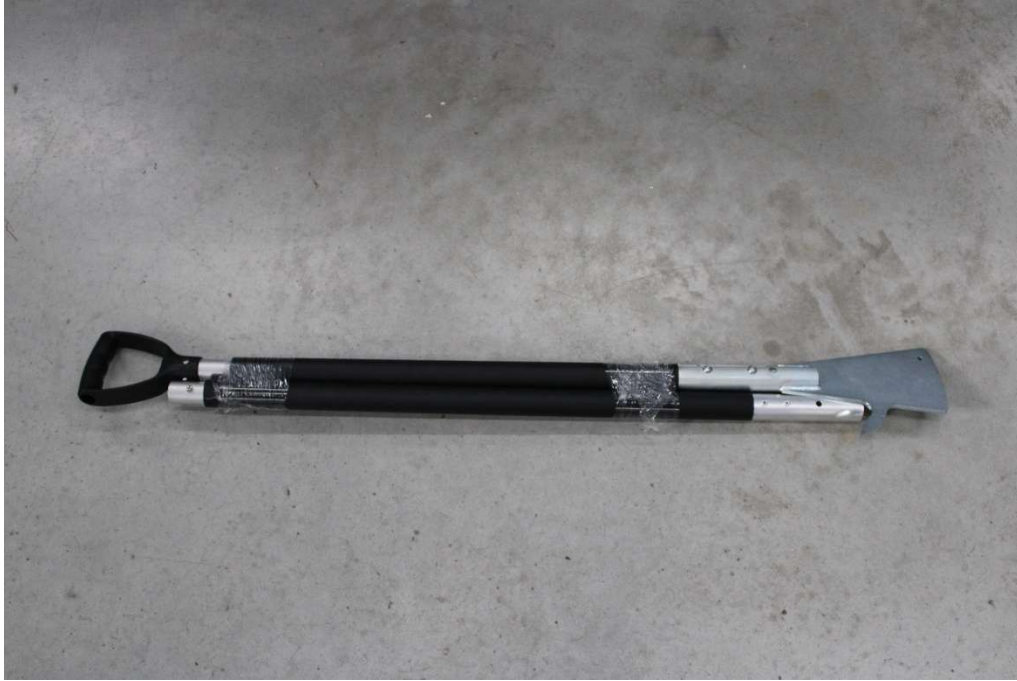
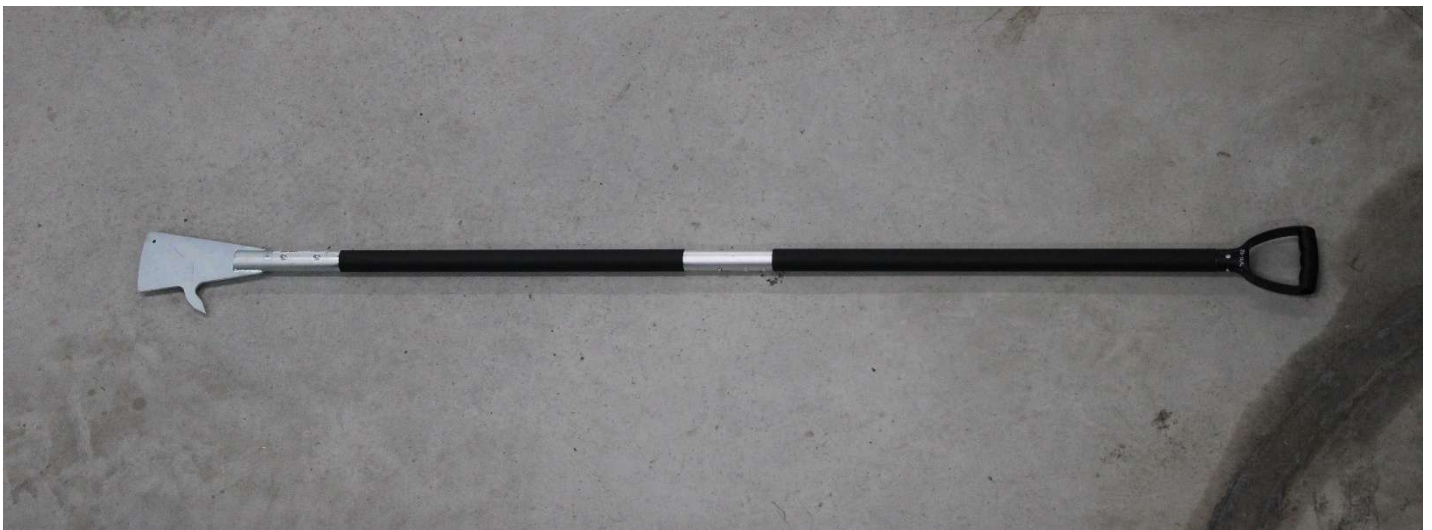
V.1 Appendix 1: Product presentation

- The tests were conducted on five ceiling hooks and their extensions, which were identified as follows (See Appendix 1):
 - 26-13/1.1 : Ceiling hook. color: black, ref 110011
 - 26-13/1.2 : Ceiling hook extension, color: black,ref 110011

Presentation of a Ceiling Hook Sample

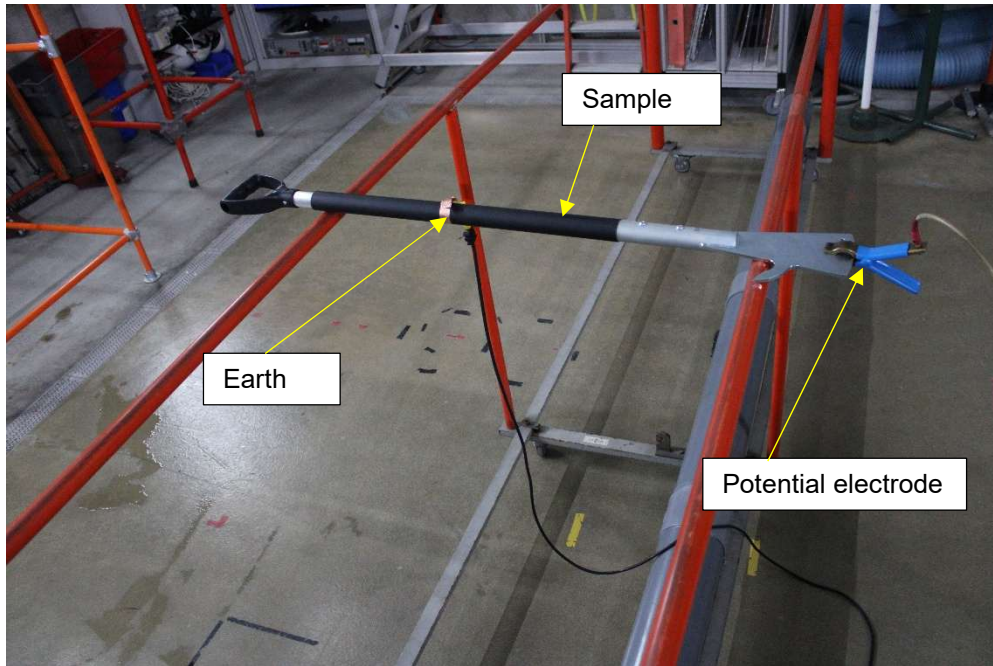
V.2 Appendix 2 : Test setup No. 1

- The test was carried out at a temperature of 21.2 °C, relative humidity of 53 % and atmospheric pressure of 10015 mbar.
- Tests between the flat hook connected to the phase and the insulating medium covered with a 25 mm wide conductive strip connected to the earth (see Appendix 2).
- The voltage must be increased from zero at a constant rate until breakdown occurs.

- At the end of the test, a perforation was observed beneath the copper strip at the tool. This could explain why the initial tension was higher than the subsequent ones

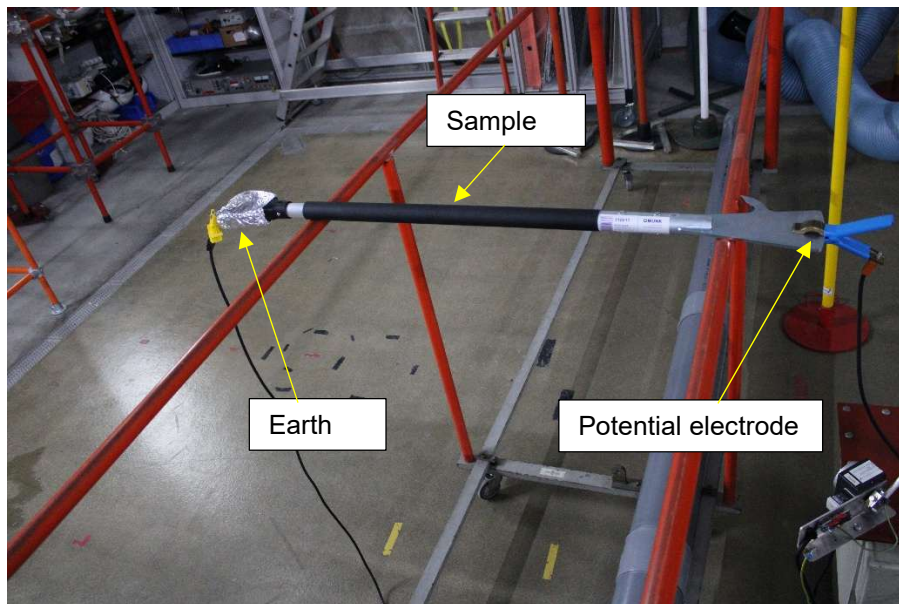
V.3 Appendix 3 : Test setup No. 2

- The tests were carried out at a temperature of 21.1°C, a relative humidity of 52% and an atmospheric pressure of 1014 mbar.
- Tests between the flat hook connected to the phase and the end of the handle covered with conductive paper and earth-connected.
- The voltage must be increased from zero at a constant rate until breakdown occurs.

- At the end of the test, a puncture was observed beneath the conductive paper under the handle, which could explain why the first voltage reading was higher than the subsequent ones (See Appendix 3).

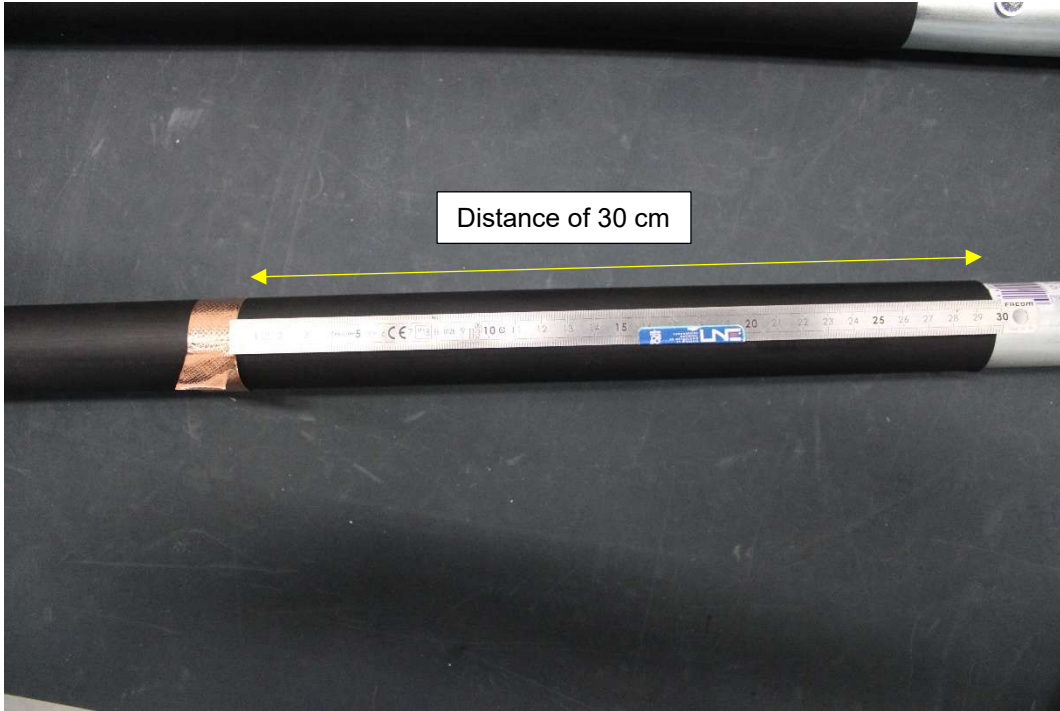
V.4 Appendix 4 : Electrode placement distance for Test No. 1

- The tests were conducted on 5 products, in the order shown in the table below:
 - Test No. 1: Tests to increase the voltage until dielectric breakdown occurs between the flat hook and the insulating medium covered with a 25-mm-wide conductive strip.

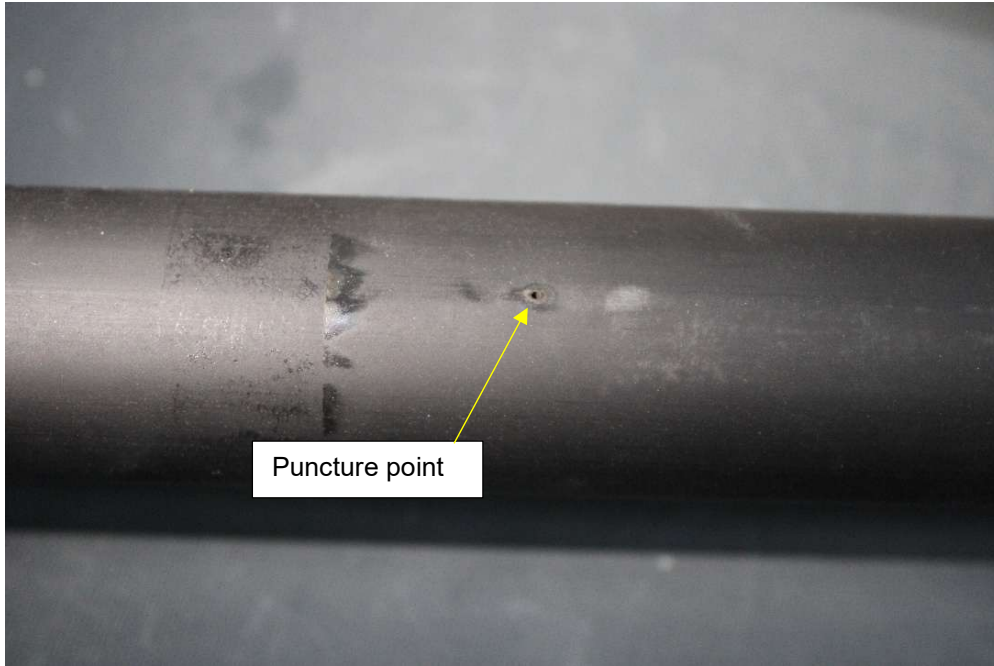
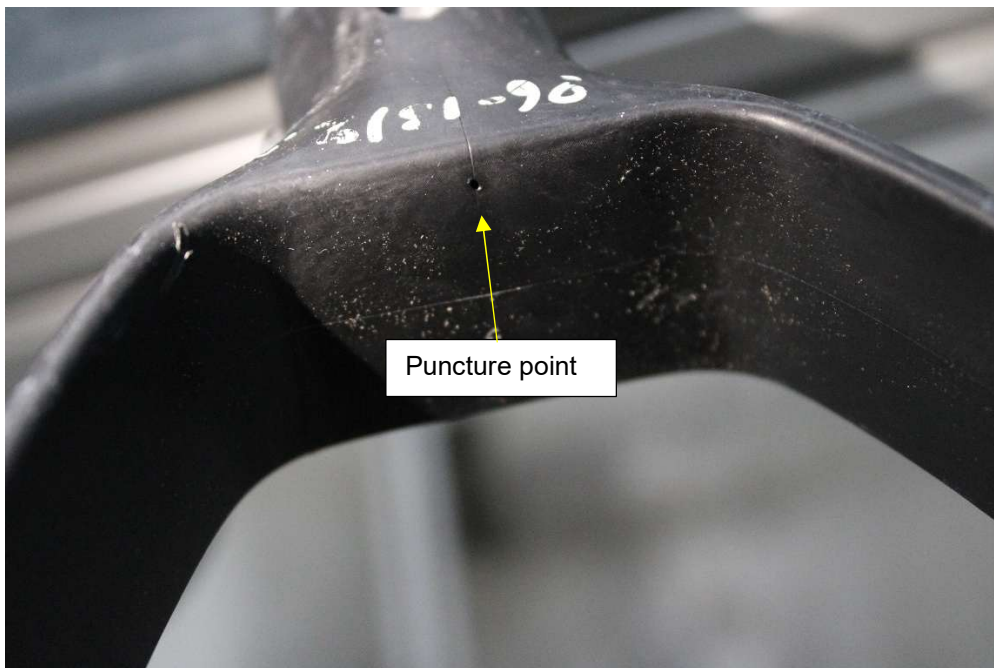
V.5 Appendix 5 : Example of one of the perforations after testing

Product	Test number	Breakdown voltage (kV)	Observation
26-13/1.1 + 26-13/1.2	1	8.98	Perforation at the location of the ground electrode where the handle is located (See Appendix 5)
	2	8.20	
	3	8.76	
	4	8.03	
	5	6.99	
26-13/2.1+ 26-13/2.2	1	7.60	Perforation at the location of the ground electrode where the handle is located (See Appendix 5)
	2	7.08	
	3	6.62	
	4	5.81	
	5	5.29	
26-13/3.1+ 26-13/3.2	1	13.17	Perforation at the location of the ground electrode where the handle is located (See Appendix 5)
	2	14.93	
	3	14.87	
	4	14.31	
	5	14.87	
26-13/4.1+ 26-13/4.2	1	8.22	Perforation at the location of the ground electrode where the handle is located (See Appendix 5)
	2	7.65	
	3	7.49	
	4	7.32	
	5	6.99	
26-13/5.1 + 26-13/5.2	1	8.03	Perforation at the location of the ground electrode where the handle is located (See Appendix 5)
	2	7.82	
	3	6.94	
	4	6.74	
	5	6.62
